Portable Police Lockups

An Analysis of Portable Police Lockups used in Victoria in the 1800s

The primary objective in writing this book is to explain how the lockup was built which may assist future restoration work.

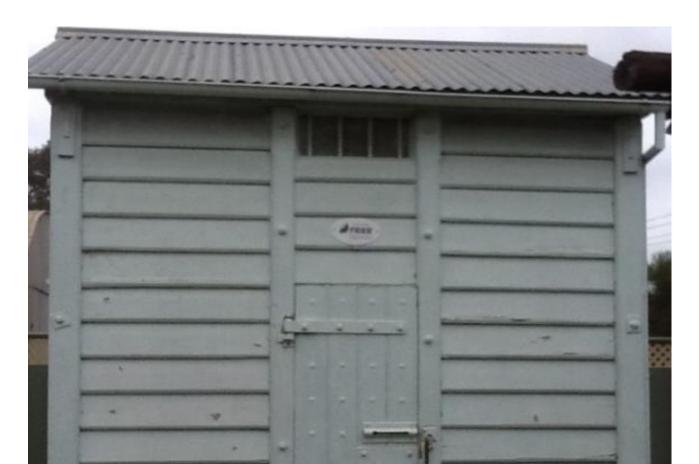
4.6.3 Broadford Lockup 2025

Broadford Lockup currently located at the Broadford and District Historical Society Precinct.

The current condition of this lockup is not good.

The Lockup at the Broadford Historical precinct is not the same lockup shown in (4.6.2). This lockup has distinctive features that can be attributed to one that was repaired or re-claimed at Dodds Street from salvaged parts; there are several reasons to support this. The left hand corner Tee iron is a smaller section than the Tee irons in the other three corners, one of the four floor bolts has been reversed, the ceiling bolts don't protrude through the rear ceiling plank

It is not likely that a new lockup would need two numbering systems. This suggests that the lockup was dismantled and repaired with salvaged components, or was built from components salvaged from a stockpile of lockups. The Lockup at St. James (see 8.11) also has a dual numbering system. This Broadford lockup has louvered gable ends large windows/vents in the front and rear walls and holes in the ceiling; it doesn't have an inspection or a servery flap, or a ventilation flue, and there are no signs of ventilation shafts having been fitted.

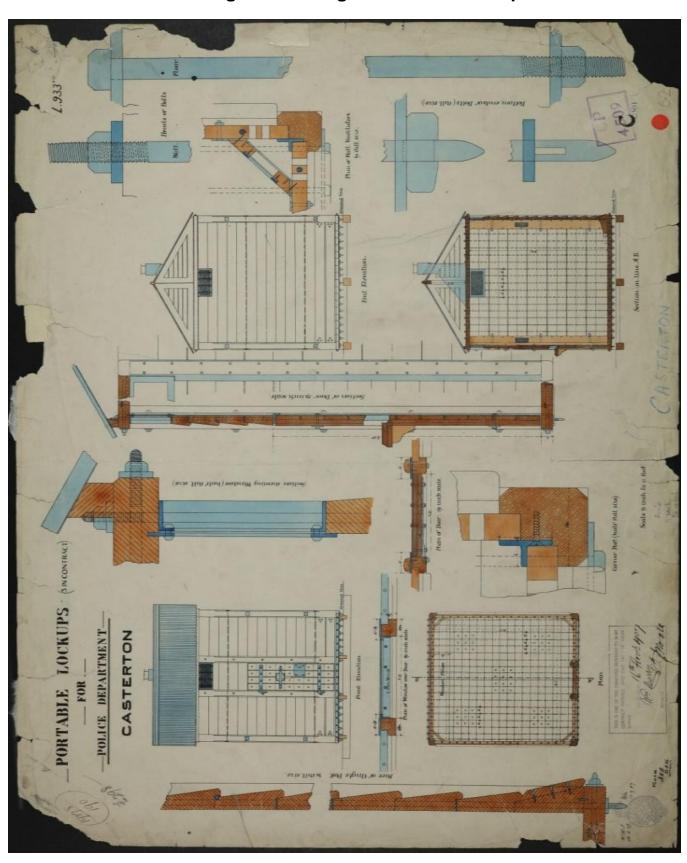
5.1 Original Drawing of Portable Lockup

The original drawing of a lockup with modifications required for three new lockups for Casterton in the western district of Victoria is commonly referred to as the 'Casterton 1907' drawing. The following drawing relates to this document and shows more clearly the details of the ventilation shaft and grill which are fitted in each corner and showing pictures of the ventilation shaft fitted to the two portable lockups located at Casterton. A small number of lockups were fitted with this ventilation arrangement.

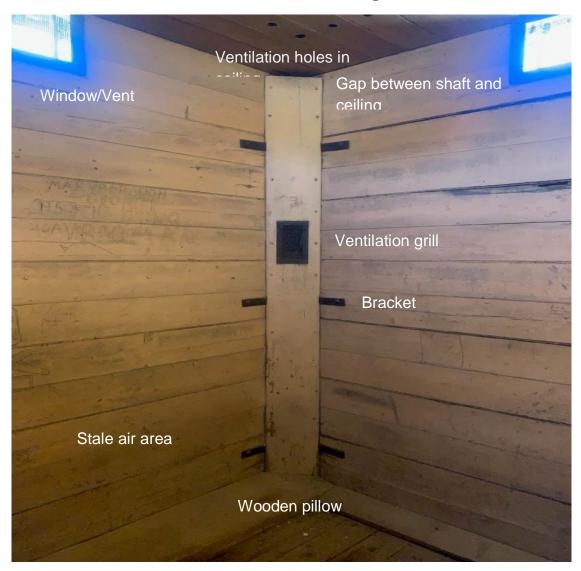
5.3 Ventilation Shaft Arrangements

Picture showing one of the four ventilation shafts inside the lockup at Casterton showing the fixing brackets, ventilation grill, large windows [two of the four shown], ventilation holes in the ceiling, the gap between shaft and ceiling, and the wooden pillow.

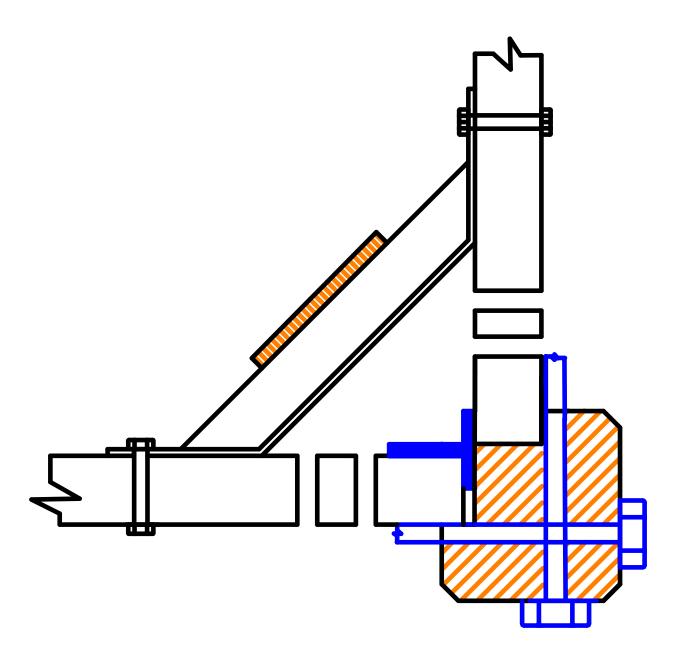
5.4 Drawing of Ventilation shaft

Few lockups were fitted with ventilation shafts and a number of these have since been removed. The two lockups, male and female, at Casterton are still intact

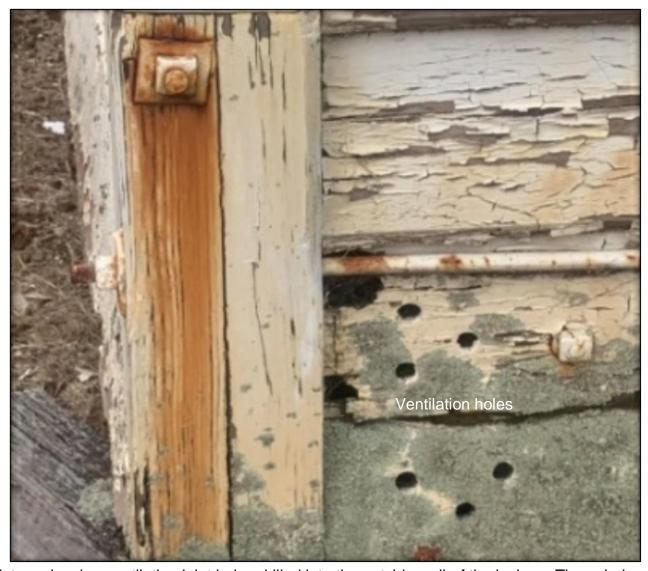
5.5 Photo showing ventilation Holes in Wall Plank

Picture showing ventilation inlet holes drilled into the outside wall of the lockup. These holes

enable fresh air to flow into the ventilation shaft inside. This is called natural ventilation, often referred to as Stack Ventilation.

A small number of lockups were fitted with this ventilation arrangement.

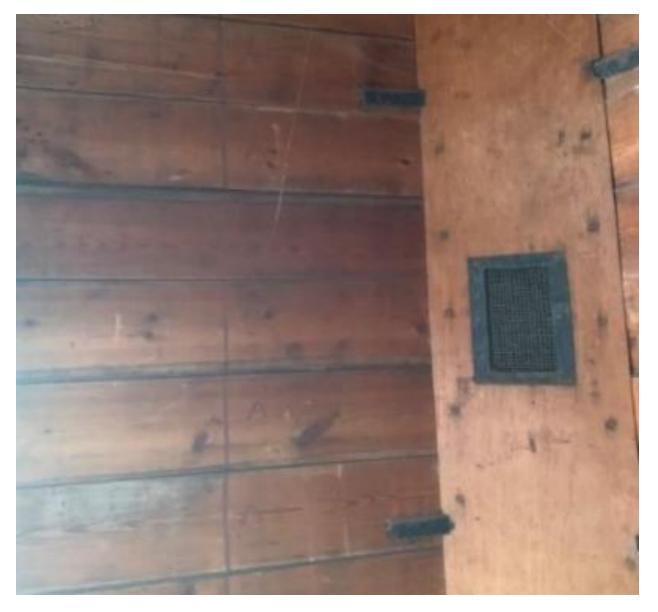
5.6 Ventilation Grill

Picture showing a ventilation grill in the ventilation shaft.

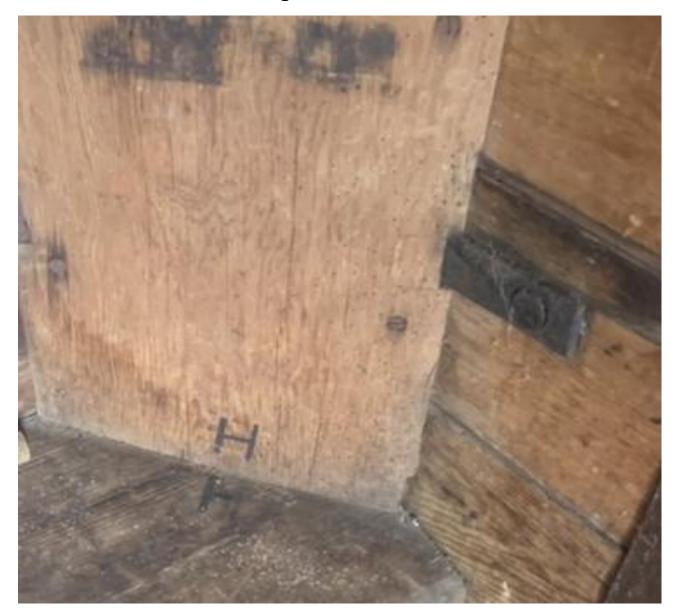
5.7 Image of Reference Mark

Picture showing the H reference mark on the ventilation shaft which is aligned with the corresponding H reference mark on the floor stamped during assembly.

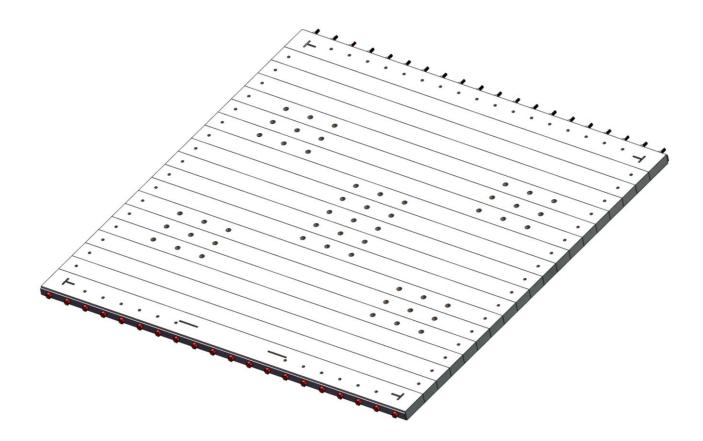
The floor and ceiling are identical and are represented here with one drawing, except for the 35 mm diameter ventilation holes which are in the ceiling only.

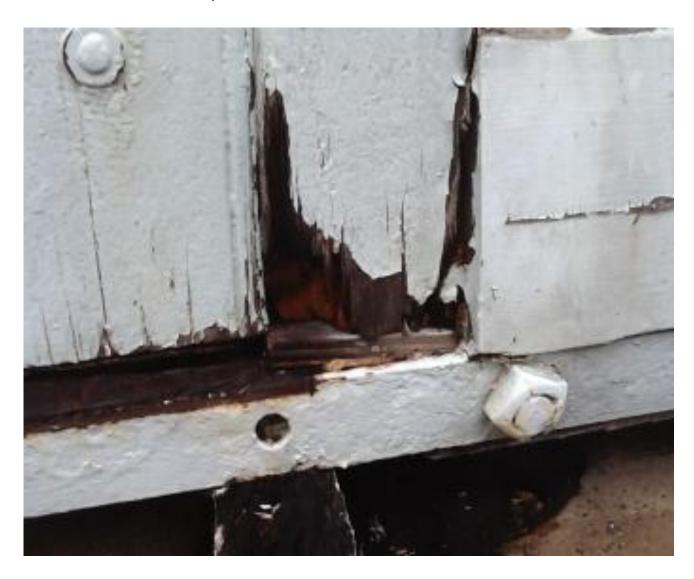
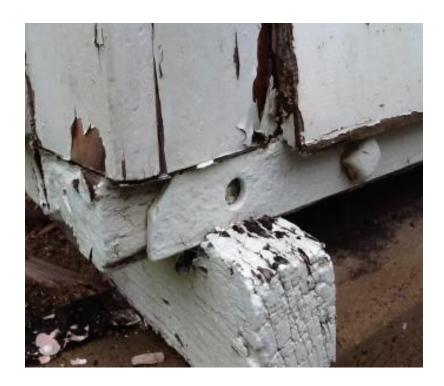
This lockup has some detailing deficiencies, particular around the door and threshold area and the corners of the building, where rainwater drips onto and pools on the floor beams causing deterioration of timber components.

Door jamb, right hand corner and left-hand corner of the lockup showing the damage caused by rainwater running off the vertical capping/post and pooling on the horizontal floor plank and then being drawn up by capillary action into the capping.

Timber is an excellent building material for structure and internal finishing's/linings but has deficiencies as an external building envelope material and needs to be finished or externally treated and carefully detailed to mitigate the agents of deterioration, primarily UV exposure and rainwater.

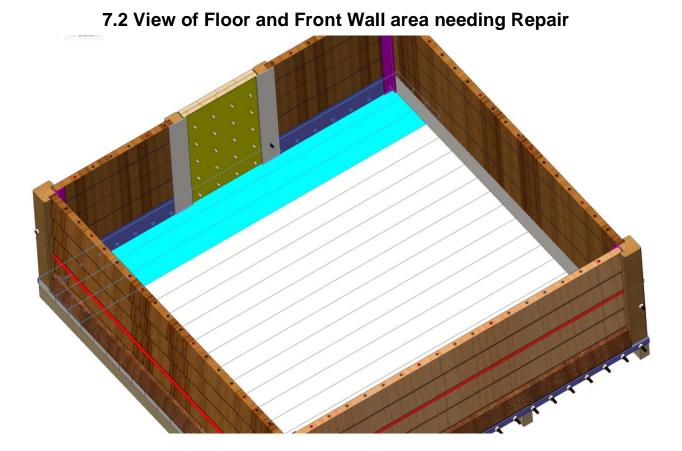
Damaged blue floor planks that need to be replaced.

Damaged dark blue wall planks that need to be replaced.

The timbers that need to be repaired/replaced are the floor planks coloured blue and the No 1 wall plank on both the right-hand and left-hand front wall coloured dark blue. To remove and replace the floor planks and the No 1 wall plank will require both horizontal and vertical bolts to be partly withdrawn, but the Tee iron corners, and the flat iron door jambs must remain. Before any bolts are removed, the floor should be stabilised to prevent disturbing the remaining floor planks, most importantly the iron door jambs (which determines the position of the door hinge gudgeons both vertically and laterally), these should be reset to the correct height and secured.

Support the building away from the bearers and beyond the first and second floor planks and remove the bearers, remove the damaged floor planks coloured blue, remove the damaged sections of the corner and door posts sufficiently to expose the No 1 wall planks colored dark blue on the front wall, remove the damaged wall planks and insert new planks, fit a new cover board [it is important that the bottom plank cover board protrudes beyond floor planks and the iron clamping plates to ensure that the dripline falls beyond the floor], prepare three new floor planks (pink, blue and green) to replace the three blue planks. Rebate the blue plank to fit around the inside face of the Tee irons and door jambs and insert the pink plank to close the gap. Fit new bearers with a 120 mm x 8 mm steel plate attached with holes drilled for the wall bolts and holes drilled to secure the plate to the floor beams and attach the steel plate to the floor planks. The steel plate would then support the corner Tee irons and door jambs. It is important to locate the Tee irons correctly as they fix the walls in their correct position, also the iron door jambs, which locate the doorway, and set the height for the door hinge gudgeons. The third plank (green outside) plank can then be fitted. Return the floor and wall bolts. Fit a new cover board to the modified wall plank to resemble the original wall plank and continue with the repair to the door and corner posts.

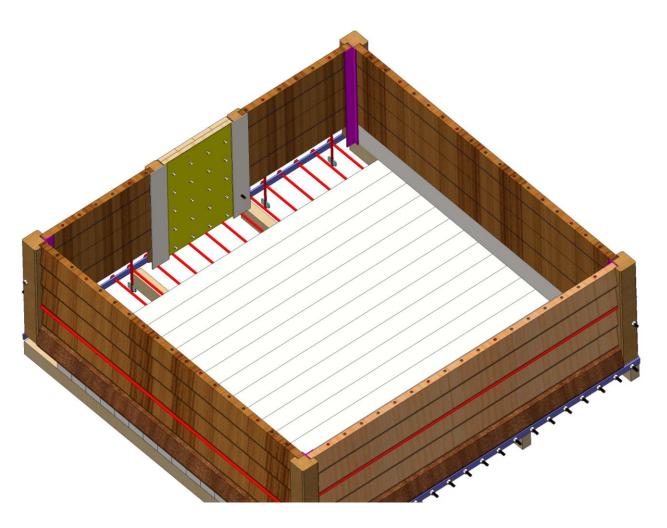
7.3 View of Front Floor and Wall Planks Removed

After removing damaged planks, the floor and wall bolts should be partly withdrawn to allow for the insertion of the new planks.

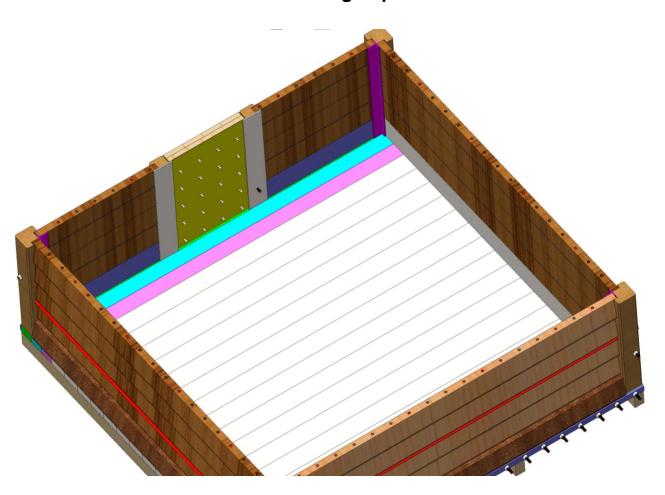
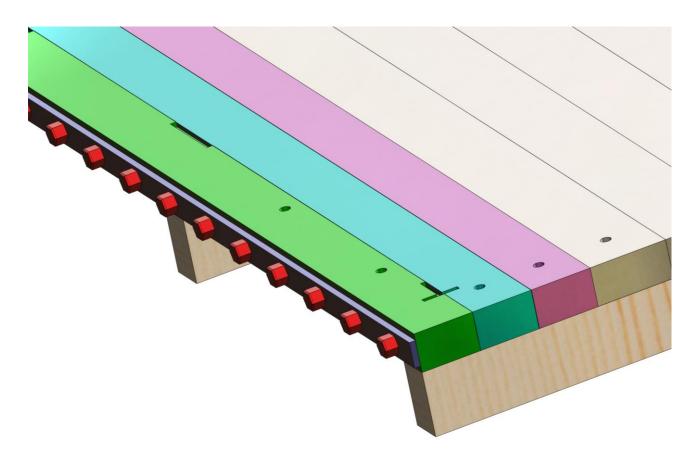
7.3 View of Showing Replaced Planks

After removing damaged blue planks, fit the new blue plank around the corner Tee iron and door jamb, insert the pink plank to close the gap, replace bearer with steel plate attached, weld Tee iron with extension to the bearer plate, insert the green plank and reinstate floor and wall bolts.

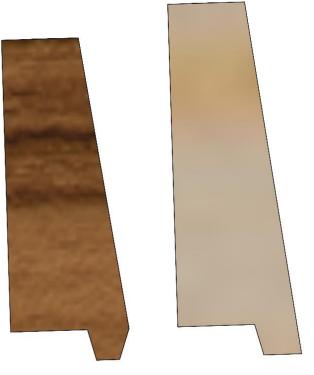
7.5 Drawing of Wall plank Profiles

The early-period wall plank shown on the right has a splayed and checked profile and were initially rough, untreated planks made from local hardwood species-the inside face measures 275mm.

The mid-period and late-period wall plank shown on the left has a splayed checked and chamfered profile, with a planned finish the inside face measures 190mm.

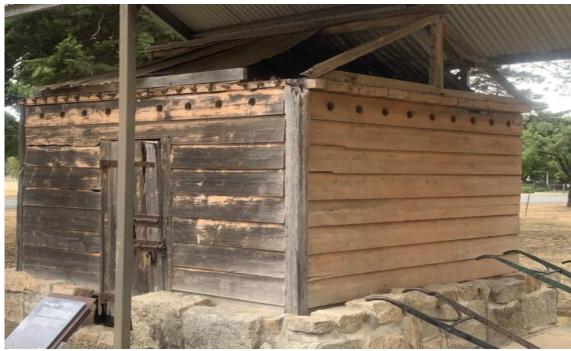
The gable ends of this lockup are missing.

The ceiling has nineteen bolts, the bottom section of the lockup has been removed, and the wall planks are splayed and checked weatherboard profile

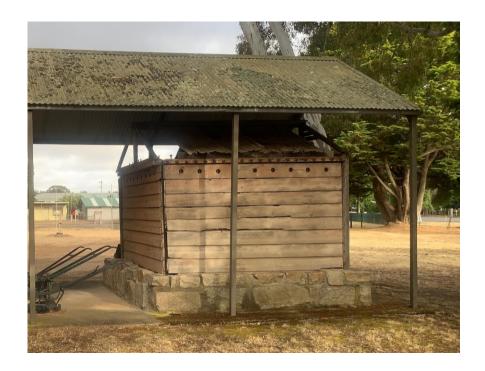
8.5 Great Western Lockup Roof Cover

This photograph shows a roof covering the Great Western Lockup. Timber buildings have deficiencies and need to be carefully treated and detailed to militate against the agents of deterioration, primarily UV exposure and rainwater. Normal building practice for timber buildings was to provide wide eaves and, in most cases, surround the building with a verandah. This is unpractical with lockups, and the best solution is to cover the building with a standalone roof structure as shown below.

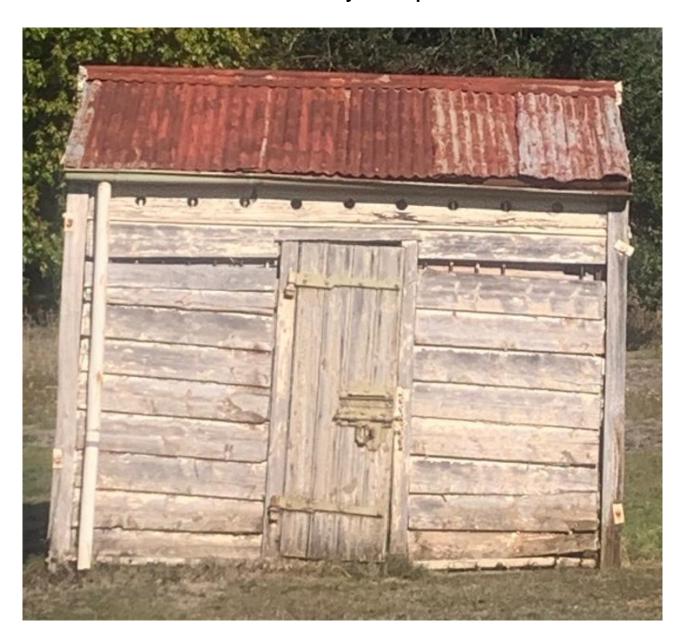
8.6 Stanley Lockup

The Stanley lockup is the only surviving intact Early period lockup, except that both gable ends are sealed by well fitted narrow planks. Unusually holes for cross ventilation are in the 10th and 8th planks on the front and rear walls respectively, and in the 8th and 9th panks on each side wall. There are no windows, inspection flap or lock, relying on a pad bolt to secure the door.

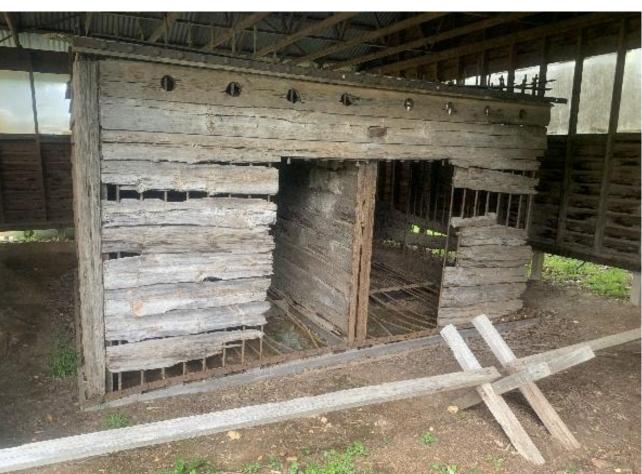
8.7 Trentham Double Lockup

The cross ventilation holes, 10 wall planks and the arrangement of the iron rods or bolts in the walls and floor are clearly visable in this rare Early period double lockup at the Trentham Police Complex. Although it has been severly ravaged by the weather, the protective shed built over it will protect it for years to come.

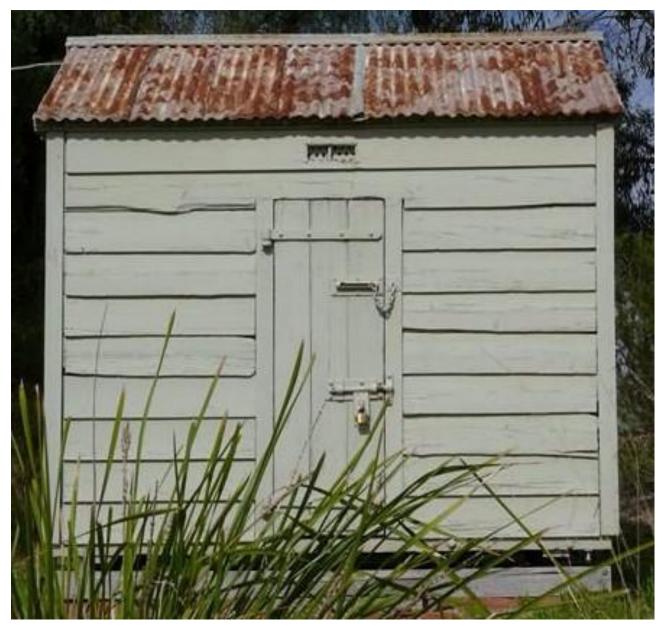
8.8 Chewton Lockup

This portable police lockup was installed in the goldfields of Chewton, Victoria in the 1860s. Its ventilation grills high on the walls are very small for a location which can get very hot in summer. The position of the inspection safety chain on the door can vary from one lockup to another.

The floor and ceiling of this lockup has 9 planks 300mm wide x 100 mm thick and one plank 150 x100mm, the backing plates for the floor and ceiling bolts are missing- perhaps attributed to the restoration works.

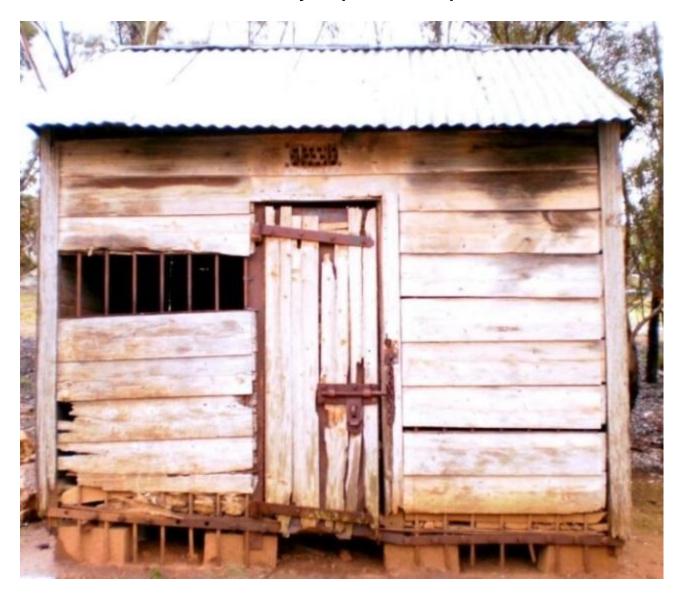
8.9 Wycheproof Lockup

The Wycheproof lockup has the nineteen floor and ceiling bolts and a small vent in each of the four walls for ventilation and the walls have ten planks with a checked weatherboard profile.

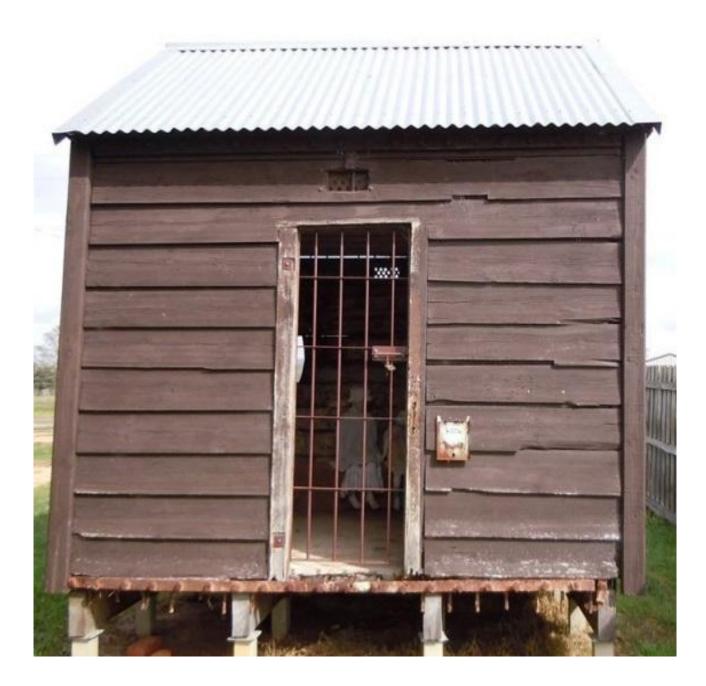
8.10 Moonambel Lockup

The Moonambel Lockup has nineteen floor and ceiling bolts and a small vent in each of the four walls for ventilation; the walls have ten planks made from Cyprus pine with a checked weatherboard profile.

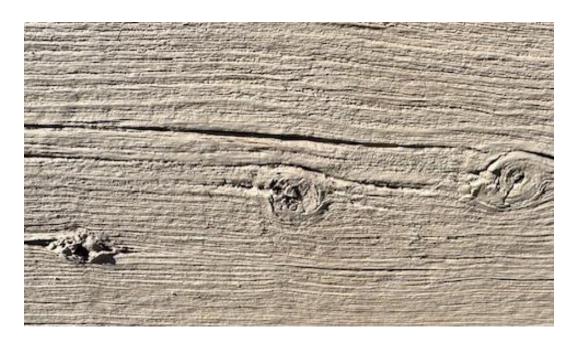
Moonambel chosen as an "early- period" lockup, showing appearance of a typical wall plank to help with the identification of the wood species.

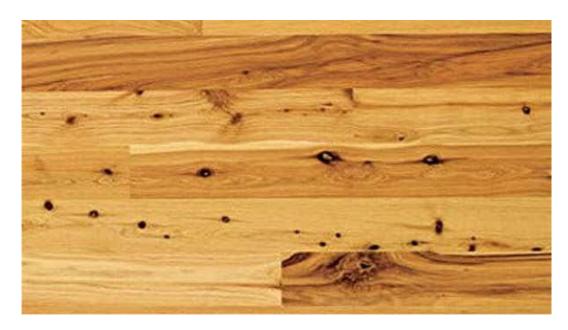
Southern Cypress Pine sample shown to help to identify the timber used in the early period lockups.

Southern Cypress Pine is a native pine that grows naturally in most states of Australia, it is highly durable, resistant to decay, rot, and water damage and is naturally resistant to termites. It is known for its straight grain, fine texture, and numerous tight knots.

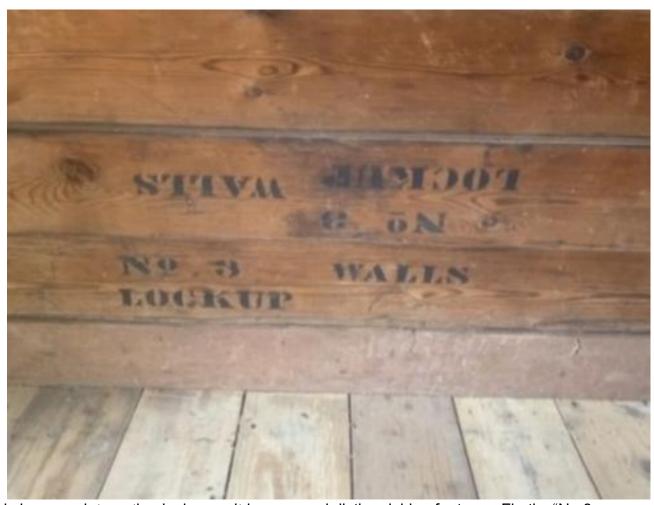
8.15.3Stencil in St James Lockup

This is a very interesting lockup as it has several distinguishing features. Firstly, "No.3 LOCKUP WALLS" stencils are on boards in at least two interior walls. The wall planks have the standard carved Roman numerals and have been re-stamped with Western Arabic numerals like the Broadford lockup, indicating that this lockup was also repaired at the workshop at Dodds Street. The stencil on No 2 wall plank is upside down. As the profile of the wall plank makes it impossible to install them upside down, these planks must have been stenciled before they were installed at St. James or at the time they were being made for a No 3 lockup. The Guildford lockup stencil lockup No6 indicates that the wall planks were in fact stenciled prior to the lockup being built and not when they were salvaged from lockups from the workshop stockpile.

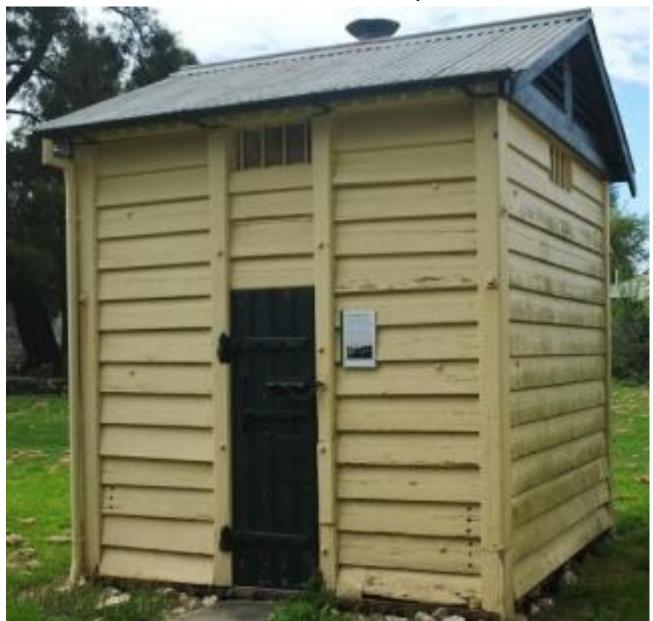
8.17 Trentham Lockup

This lockup is located at the Trentham Police Complex and is very similar to the lockup in Casterton, as it has a ventilation shaft in each corner, a large window/vent in each of the four walls, louvers in the gable roof ends and a ventilation flue in the roof.

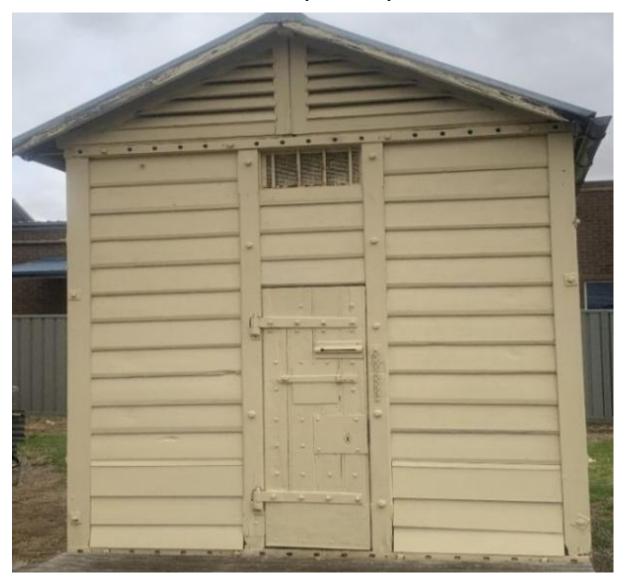
8.24 Edenhope Lockup

Note the orientation of the roof. The gable is above the door and the roof is not aligned with the building which is contrary to all other lockups except Maffra. Perhaps the installing contractor used his discretion to take advantage of the prevailing winds to assist with ventilation, or the lockup is one of the rebuilds from salvaged parts (as indicated by the four bolts in the floor and ceiling).

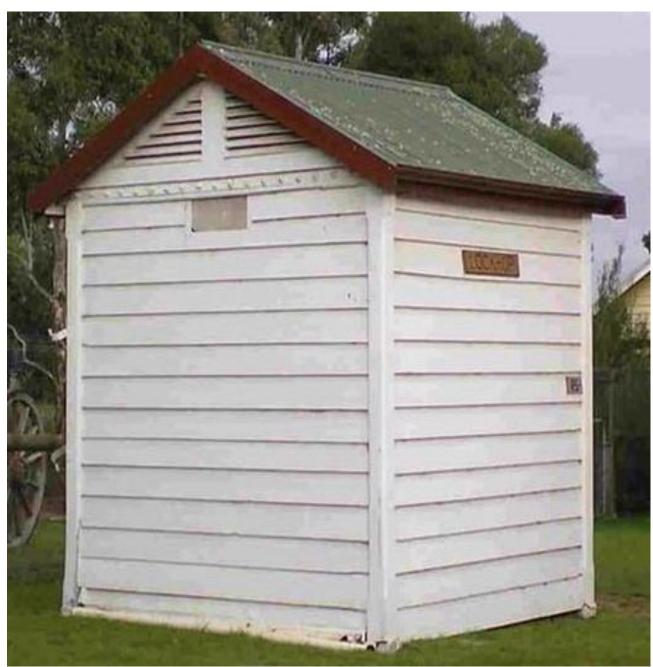
8.25 Maffra Lockup

Note the orientation of the roof, the gable is above the door, which is contrary to all other lockups except Edenhope. Perhaps the installing contractor used his discretion to take advantage of the prevailing winds to assist with ventilation or the lockup is one of the rebuilds from salvaged parts as indicated by the four bolts in the floor and ceiling and that this was the best fit.

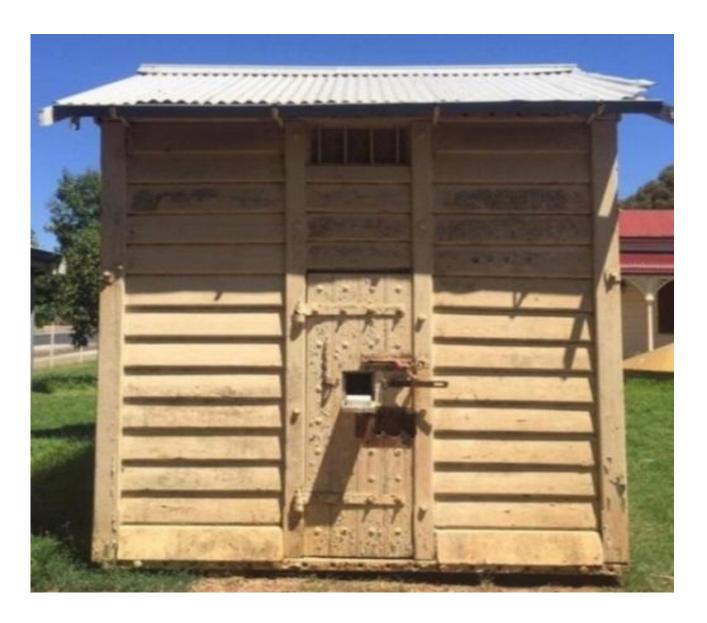
8.26 Koo wee Rup Lockup

This is a typical late-period lockup. It has a lockable bottom hinged inspection flap, which is open and resting on a supportave wooden bracket, suggesting it was also used as a servery door. Very few brackets survive, although evidence of there being is widespread.

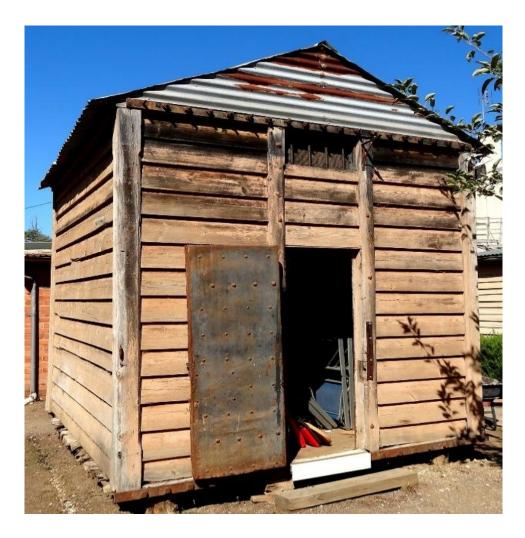
Guilford Lockup, like Mafra and Edenhope has the gable end of the roof over the door, most likely not the original roof. With a stencil on a wall plank that is upside down similar to the stencil on the Tatura lockup. The 19 bolts in the floor indicates that this is a mid-period lockup-the stencil must have been applied prior to assembling the lockup.

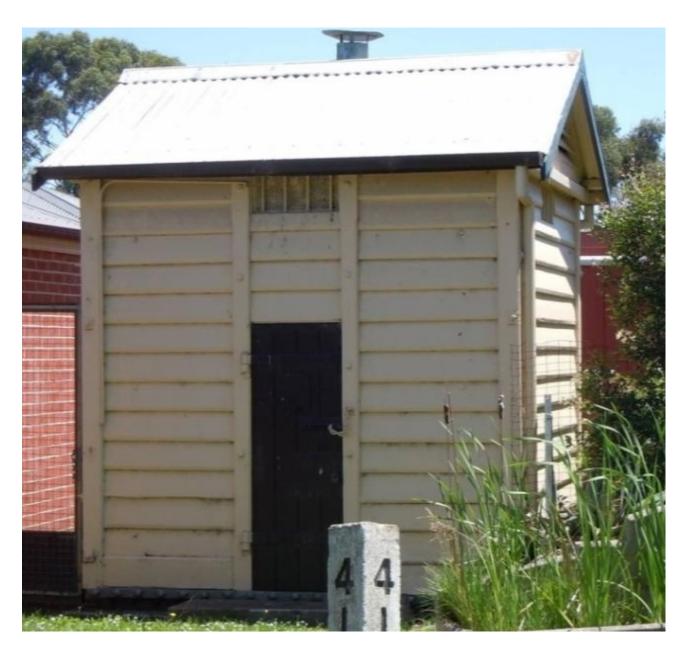
8.29 Kaniva Lockup

The Kaniva lockup is one of the few lockups to retain the ventilation flue.

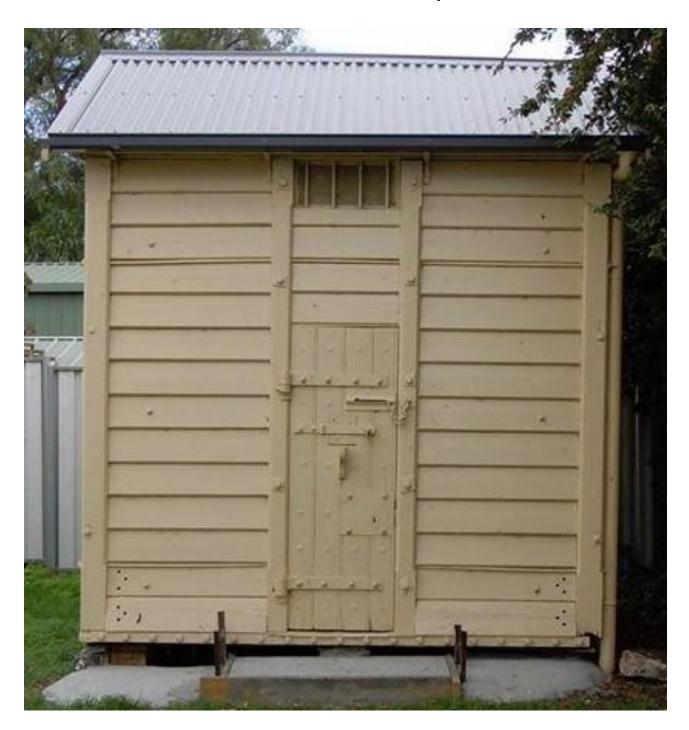
8.30 Penshurst Lockup

The Penshurst lockup is mid-period with ventilation shafts fitted as indicated by the bolts securing the shaft brackets and the ventilation holes in the bottom wall planks. The inspection flap is side hinged, the bracket below the door usually associated with bottom hinge servery flap seams un-necessary.

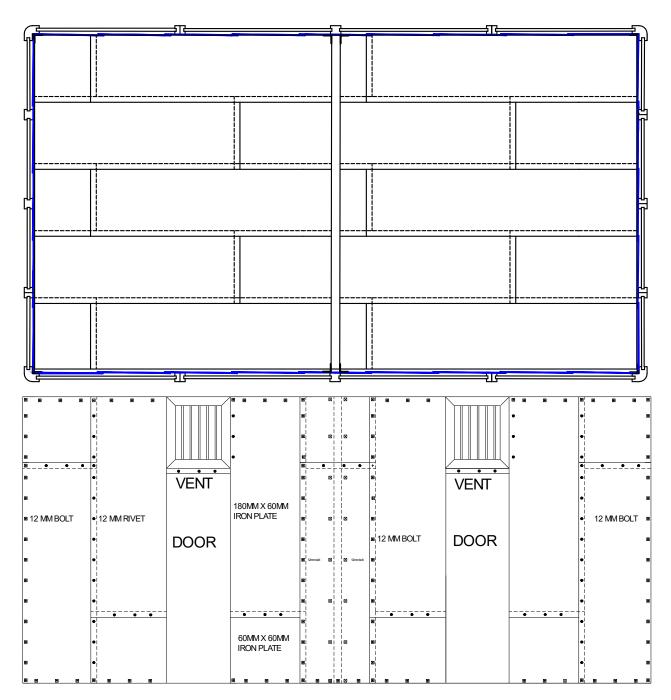
13.1 Plan view of the iron lockup

Iron lockups were built with sheets of 3/8 inch (9.5mm) iron plate 6" x 24" (180 mm x 600mm) riveted together to form panels comprising 3 panels measuring 2400 x1740 mm, and 4 panels measuring 2400 x 2320 mm, then these panels were bolted together to form the walls, floor and ceiling. Tenders were called for Portable Wooden Lockups in 1856. Also, for iron lockups as they were considered an improvement to the wooden lockup, instead they were found to be entirely unsuitable for the extremes of temperature in Victoria, causing complaints from the prisoners about the insufferable heat during the day and closeness and foulness of the air during the night.

This is a view of the front wall of a two-cell iron lockup, showing iron plates 180mm x 600mm riveted together at the factory to form panels of four and then bolted together on- site to form a complete wall. The walls are joined at the corners bolted to a 75x75 mm angle iron frame; the floor and the ceiling are bolted in a similar way. The doors are opened inwards.
